HUMAN FACTORS ASSESSMENT: M9 ARMORED COMBAT EARTHMOVER (ACE)

April 1988

REPORT DOCUMENTATION PAGE		READ INSTRUCTIONS BEFORE COMPLETING FORM																
1. REPORT NUMBER ARI Research Note 88-12	2. GOVT ACCESSION NO.	3. RECIPIENT'S CATALOG NUMBER																
4. TITLE (and Subtitle) Human Factors Assessment: M9 Armored Combat Earthmover (ACE)		5. TYPE OF REPORT & PERIOD COVERED Final Report February 1983 - December 1985																
7. AUTHOR(s) Gregory S. Krohn		6. PERFORMING ORG. REPORT NUMBER																
9. PERFORMING ORGANIZATION NAME AND ADDRESS Essex Corporation 333 North Fairfax Street Alexandria, VA 22314		8. CONTRACT OR GRANT NUMBER(s) MDA 903-83-C-0033																
11. CONTROLLING OFFICE NAME AND ADDRESS U.S. Army Research Institute for the Behavioral and Social Sciences, 5001 Eisenhower Avenue, Alexandria, VA 22333-5600		10. PROGRAM ELEMENT, PROJECT, TASK AREA & WORK UNIT NUMBERS 2Q263739A793																
14. MONITORING AGENCY NAME & ADDRESS (if different from Controlling Office) - -		12. REPORT DATE April 1988																
		13. NUMBER OF PAGES 185																
		15. SECURITY CLASS. (of this report) Unclassified																
		15a. DECLASSIF

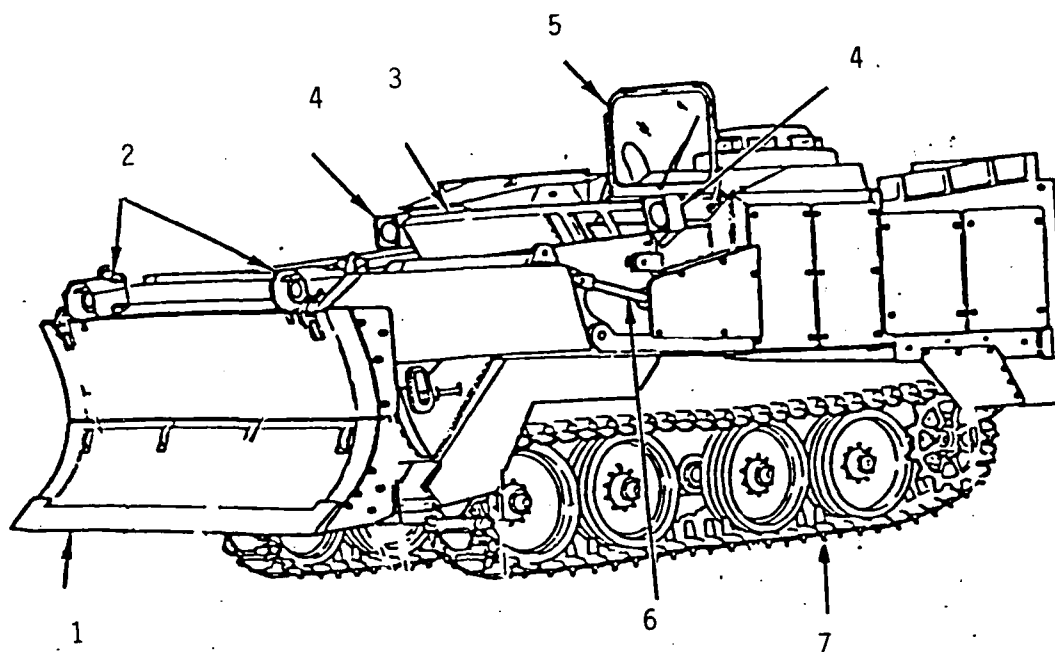
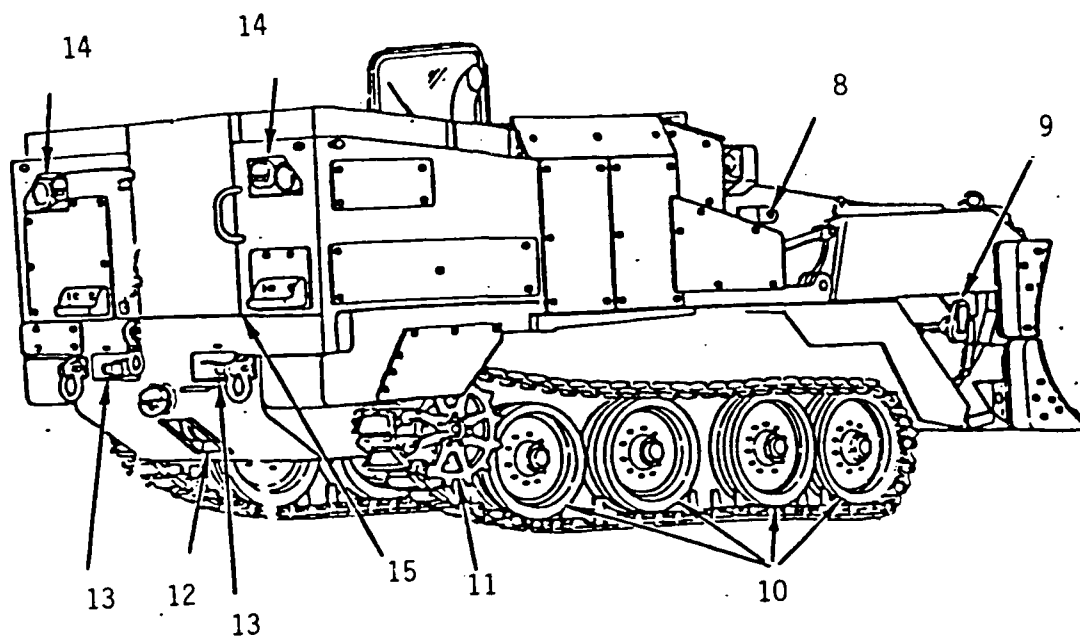
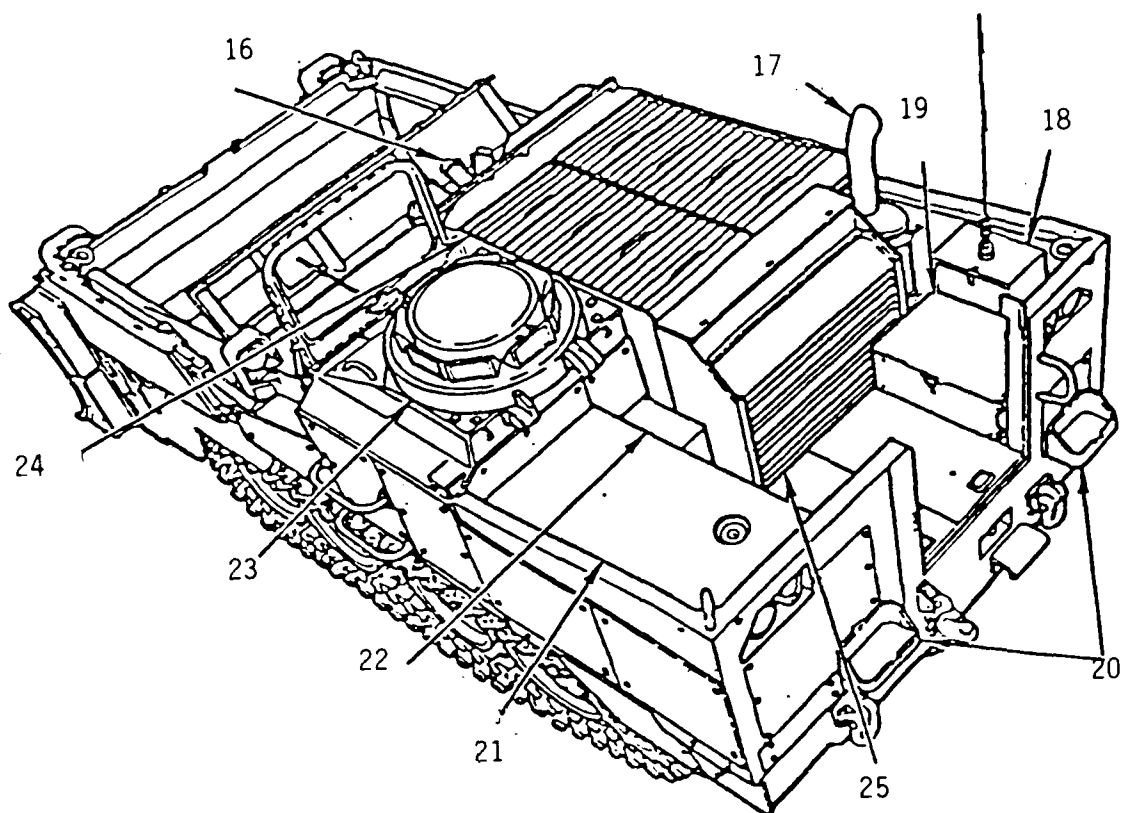
1. APRON AND DOZER ASSEMBLY. The operator must unsafely crawl beneath the dozer blade in order to prepare it for folding.
2. HEADLIGHTS. The lights do not conform to the Army Secure Lighting Program.
3. EJECTOR. There is no ejector blade lockout device to prevent its being retracted when personnel work in the bowl. The ejector cylinder (not shown) must be removed before other major components can be removed.
4. FLOODLIGHTS. The lights are frequently broken by collisions with trees.
5. WINDSHIELD. The windshield is frequently broken by collisions with trees.
6. APRON CYLINDER. The lubrication points are blocked by an armor panel.
7. TRACK. The track pads frequently wore out and may have increased vehicle vibration.

8. UPPER APRON LOCK PINS. Pin openings must be perfectly aligned in order to insert the pin. Two people are required to perform the task.
9. LOWER APRON LOCK PIN. The pins were difficult to remove due to the tightness of their fit. The pins were deformed by operators hammering them in and out of position.
10. ROADWHEELS. Rubber broke off the roadwheels and may have increased vehicle vibration. Roadwheels are hazardous to remove and replace.
11. FINAL DRIVES. The final drives must be drained in order to check the fluid levels.
12. WINCH ASSEMBLY. The winch is under capacity. The wire rope broke frequently. The wire rope wraps unevenly on the drum. There is no winch brake.
13. REAR STEP. The step was crushed in collisions.
14. TAILLIGHTS. The lights do not conform to the Army Secure Lighting Program.
15. REAR DOOR. The door is difficult to lift when installing or stowing it.

16. SMOKE GRENADE LAUNCHERS. The launchers are difficult to load from the sloped roof of the engine housing.
17. MUFFLER. Debris trapped in the muffler well was caught on fire. The radio cables were burned by heat generated from the muffler.

24. & 25. INTAKE AND EXHAUST GRILLES. The upper intake grilles are heavy and there is no place for the operators to stand when removing them. The rear exhaust grilles exhaust heat that burns items stowed on the rear deck.

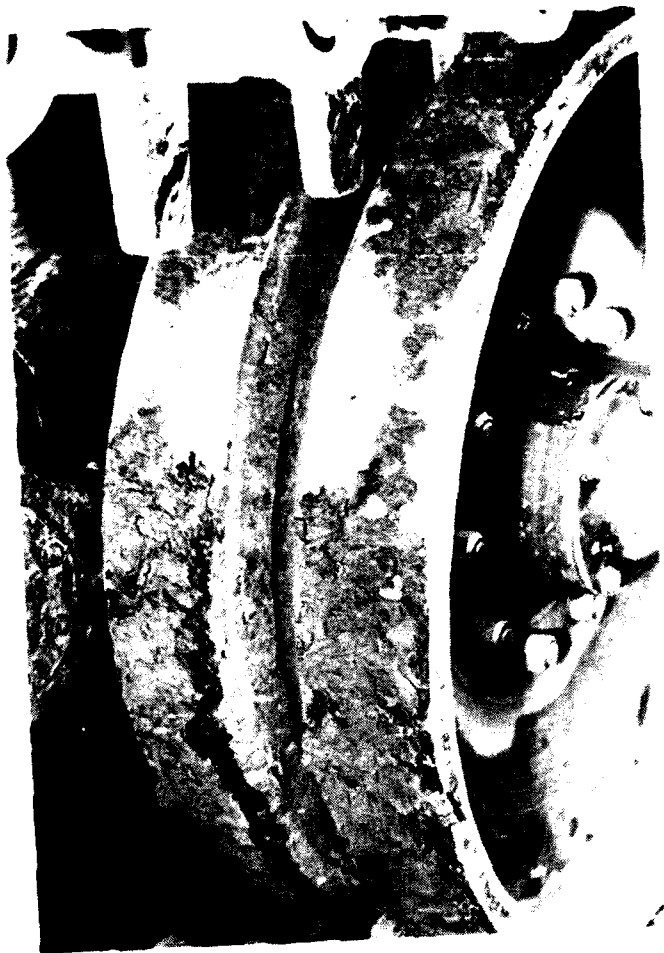
Figure 7. Deterioration of the rubber on the roadwheels.

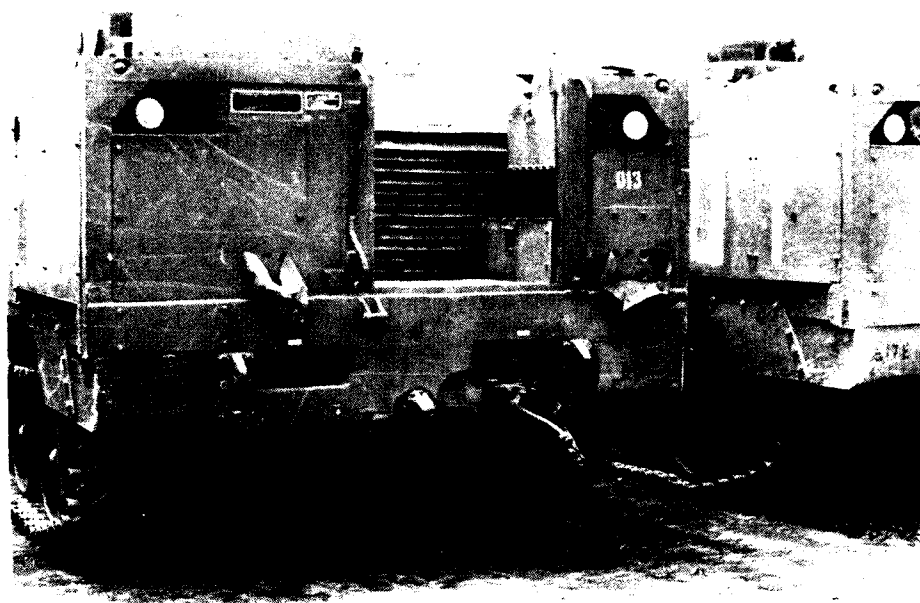
Implications for the Operator and the Equipment: Stowed equipment on the rear of the vehicle was frequently damaged by collisions with objects to the rear of the vehicle. Stowed equipment on the rear deck of the vehicle was affected by the high engine temperature. The stowed equipment blocked the air flow and affected the efficiency of the cooling system. Stowage locations that are difficult to access increase the time it

Figure 18. The damage to the rear of the vehicle. (The winch cable, the rear steps, the jerry can holders, and the handrails are broken.)

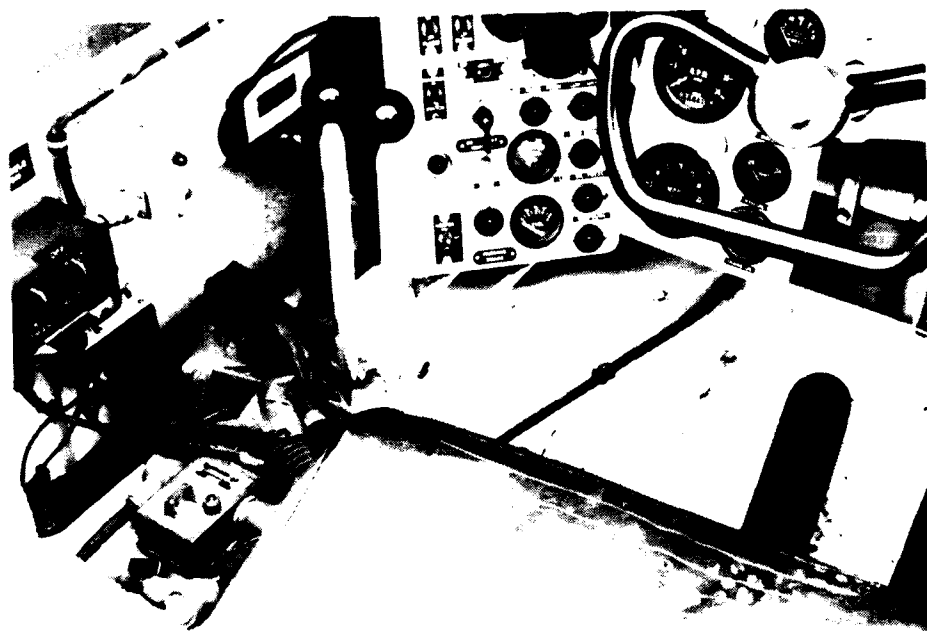
Figure 19. The suspension control levers (center left) that are too close together.

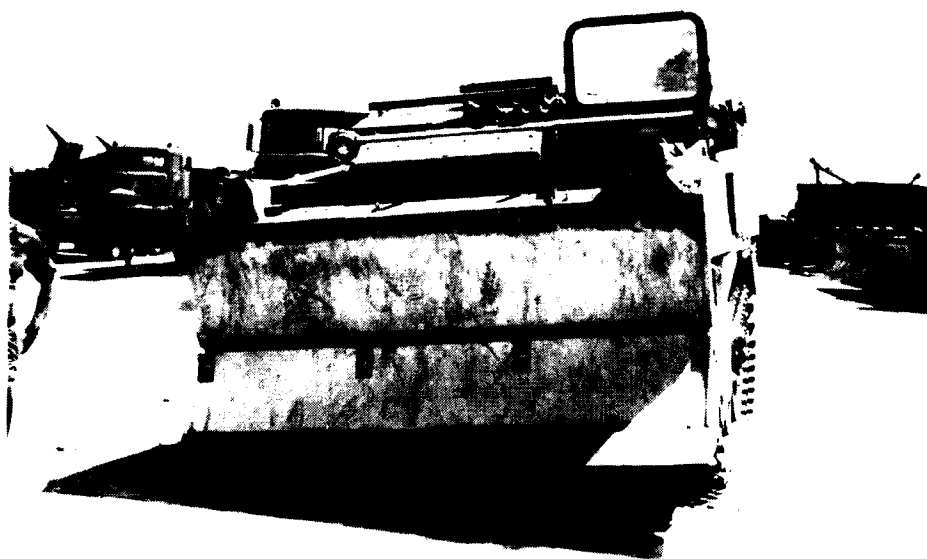
Figure 20. The operator lowering the suspension (unsprung) with one side responding more rapidly than the other.

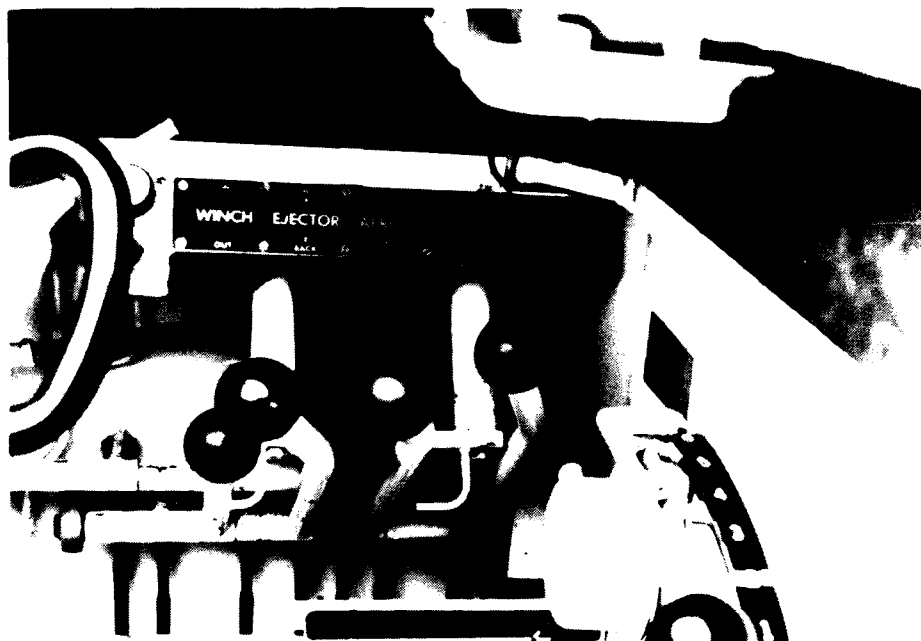
Figure 21. The bilge pump lever (furthest to the right) and the bilge pump light was above the lever but cannot be seen.

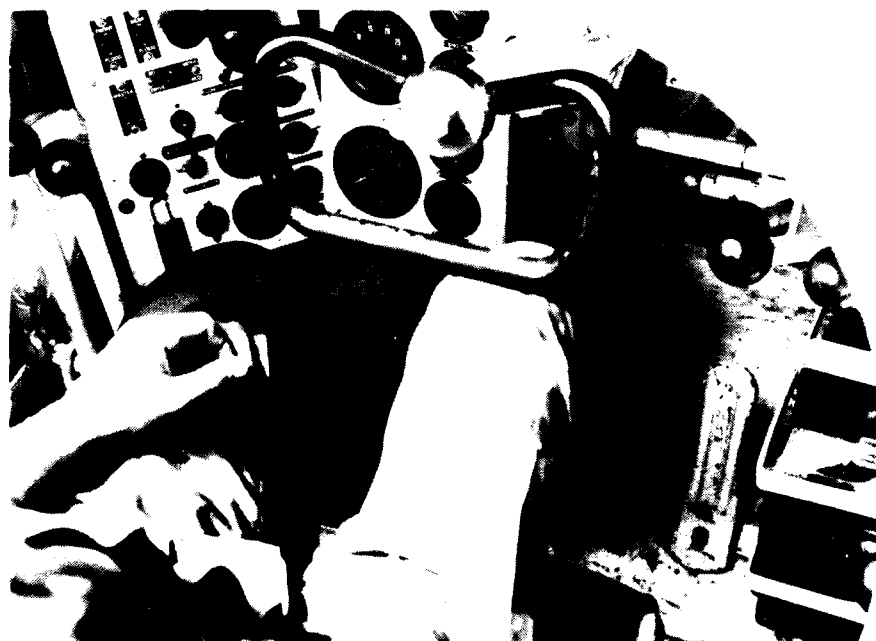
Figure 22. The operator's foot and leg position when using the brake pedal.

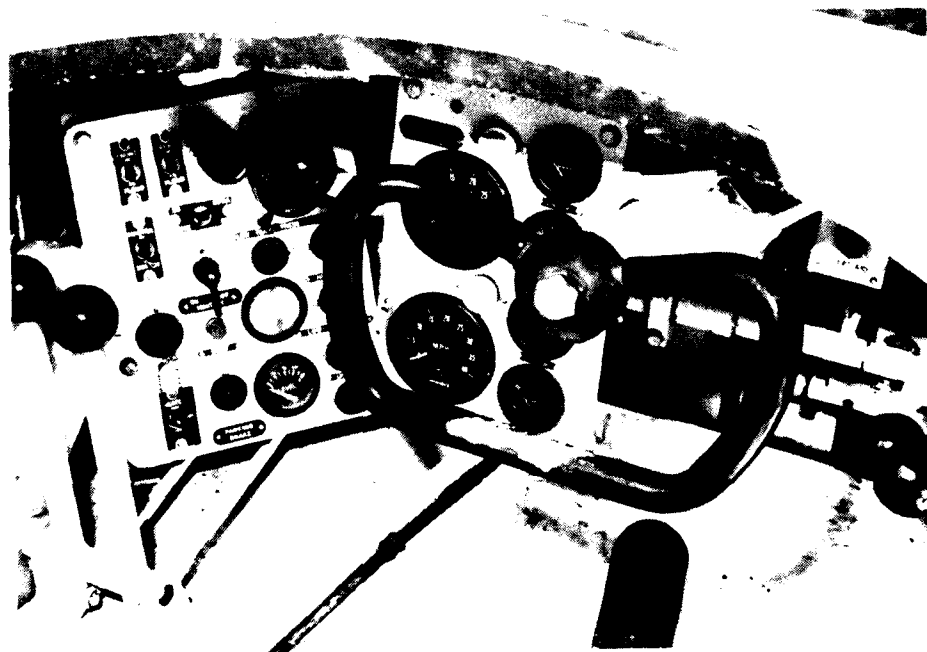
Figure 24. The operator's displays without colored operating ranges.

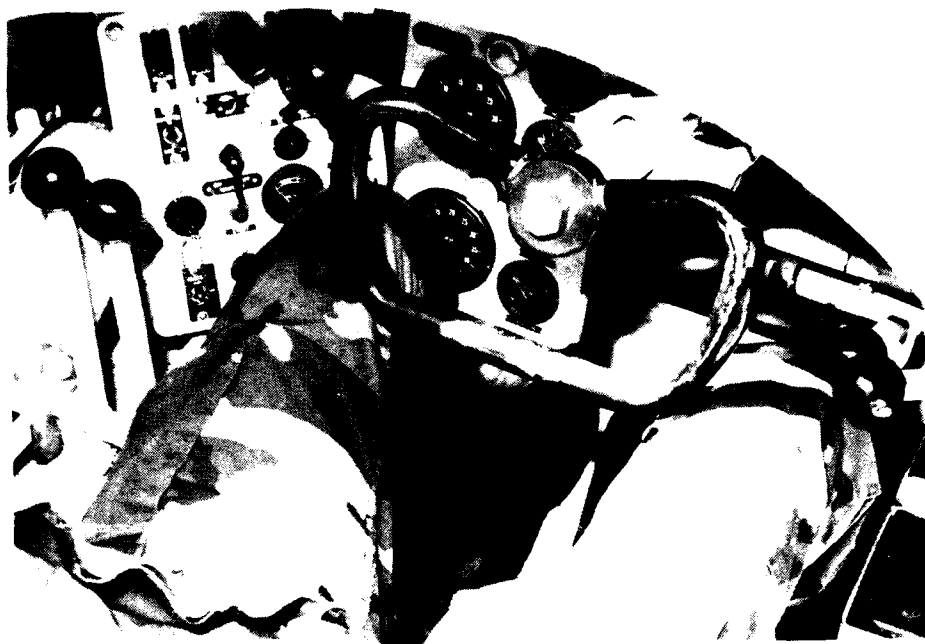
Figure 26. The operator's legs interfering with the steering control.

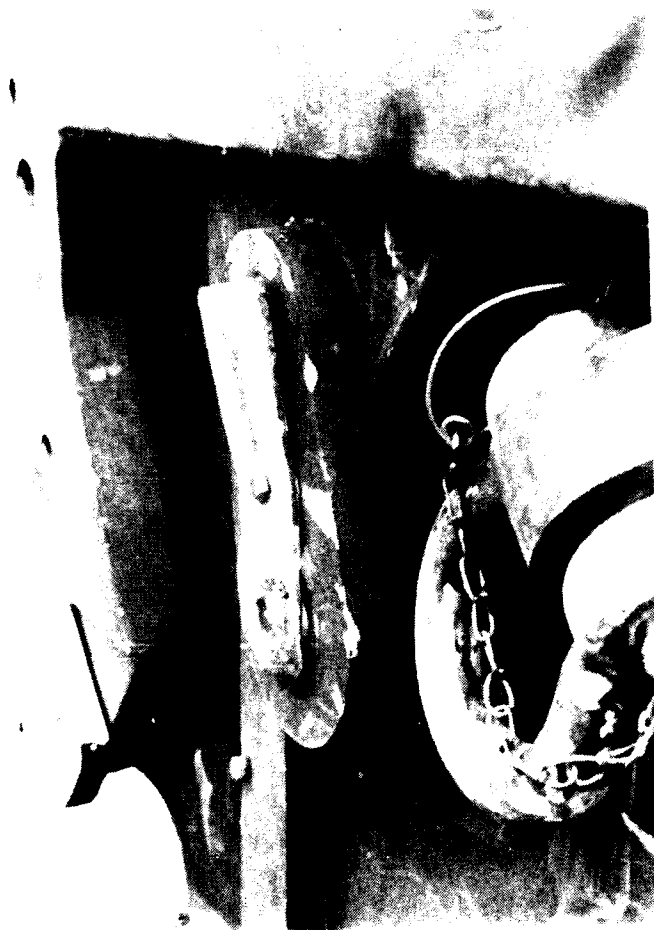
Description of the Deficiency: Figure 27 shows the apron lock pin with marks from hammering on the lower portion of the oval plate. All of the operators reported that the two apron pins, securing the left and right apron to the hull, were driven in and out of place using hammers. The fit of the lock pins into the openings was too tight for easy removal. Continued hammering deformed the pins adding to the problem.

Figure 27. The oval plate of the apron lock pin and hammering marks.

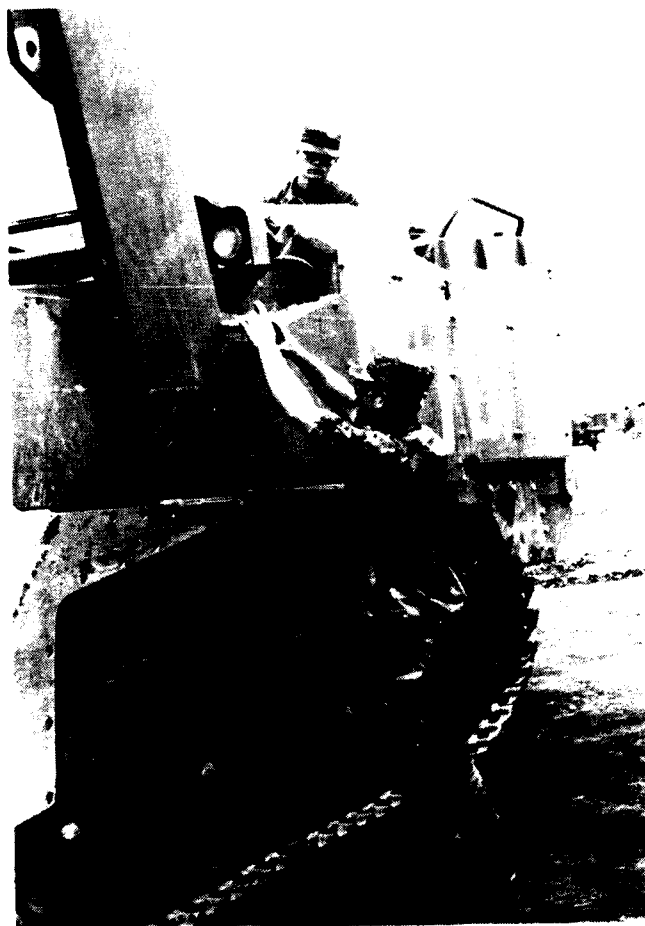
Figure 29 shows a mechanic inserting the apron safety pin while the operator adjusts the height of the apron. Inserting and removing the apron lock and safety pins required two people to perform the task in order to align the pin openings and quicken the procedure. Otherwise, without two people, the one operator must mount and dismount the vehicle repeatedly attempting to align the pin openings until the pins can be inserted. This task may violate the vehicle's design criteria emphasizing that one operator must be able to perform all tasks alone.

Figure 29. A mechanic assisting the operator in inserting the apron safety pin.

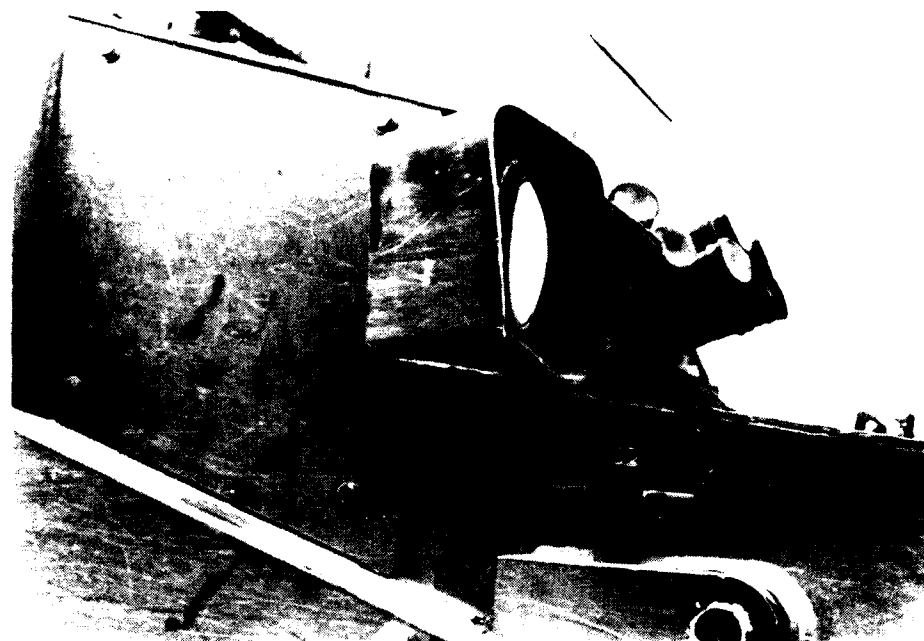
Figure 30. Damage to the floodlight guard

1. Place the side mounted floodlights in protected locations more inboard on the vehicle than the present locations. Perhaps, floodlights could be located inboard at a greater height on a removable stand or fixture.
2. Add lights meeting the requirements of the Army Secure Lighting Program.

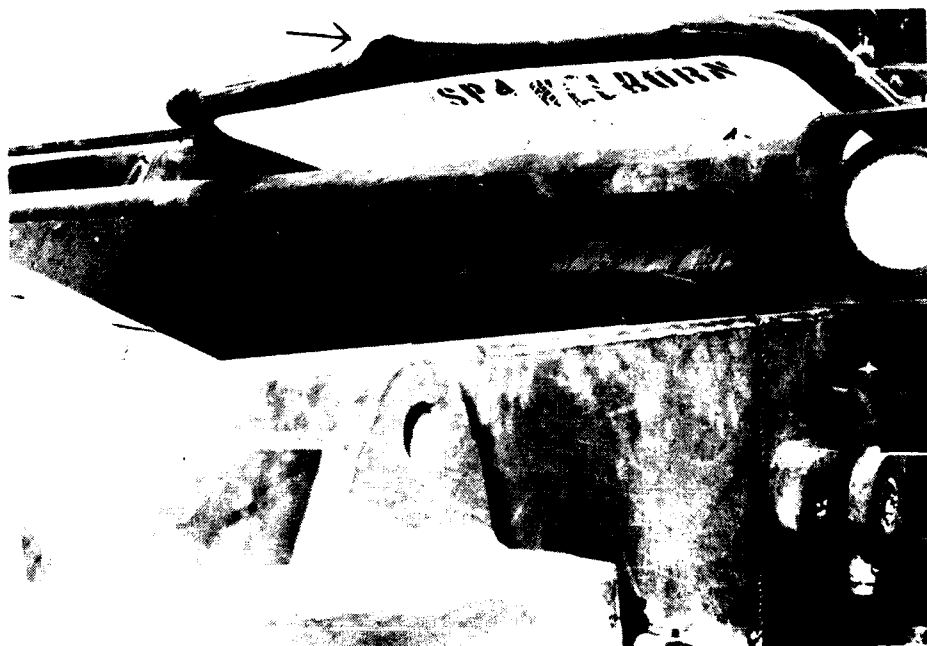
Figure 35. A shattered windshield and damaged windshield frame.

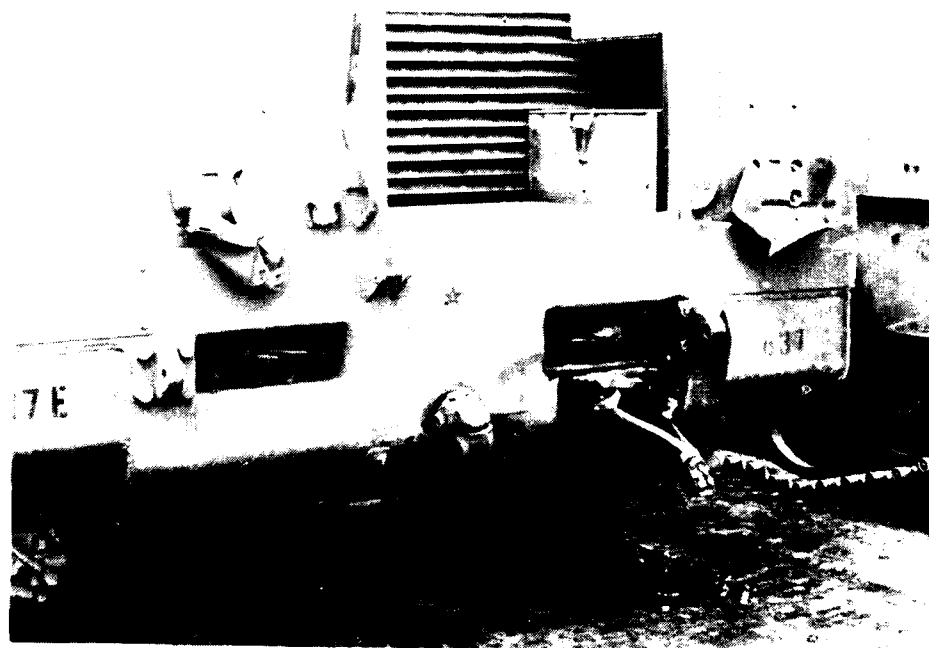
Figure 39. The crushed rear step and handrail.

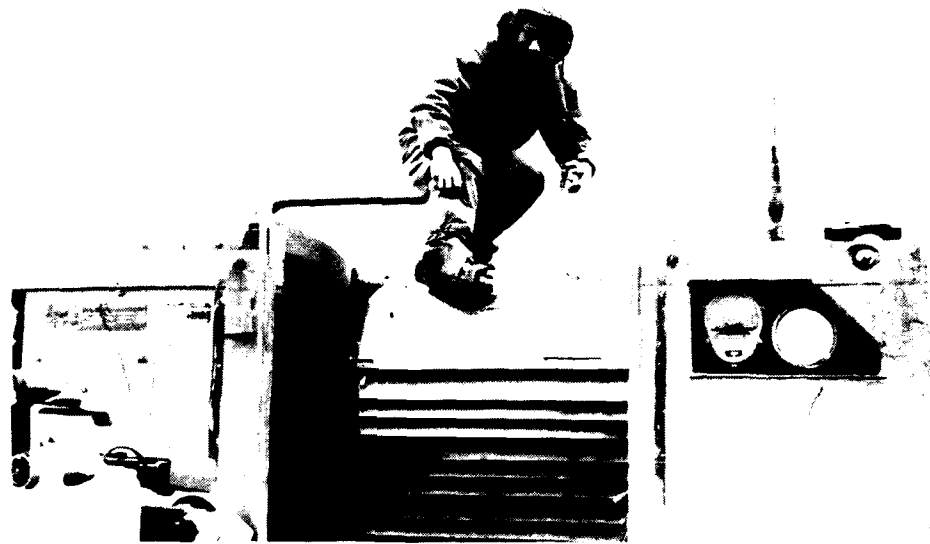
1. The radiator housing. Figure 40 shows an operator trying to step down from the radiator housing.
2. The smoke grenade launcher area including the sloped deck above the tool box.
3. The right and left apron cylinder areas used by personnel to enter or exit the bowl. Figure 41 shows an operator climbing up by the apron cylinder in order to see into the bowl.

Figure 40. An operator stepping down from the radiator housing.

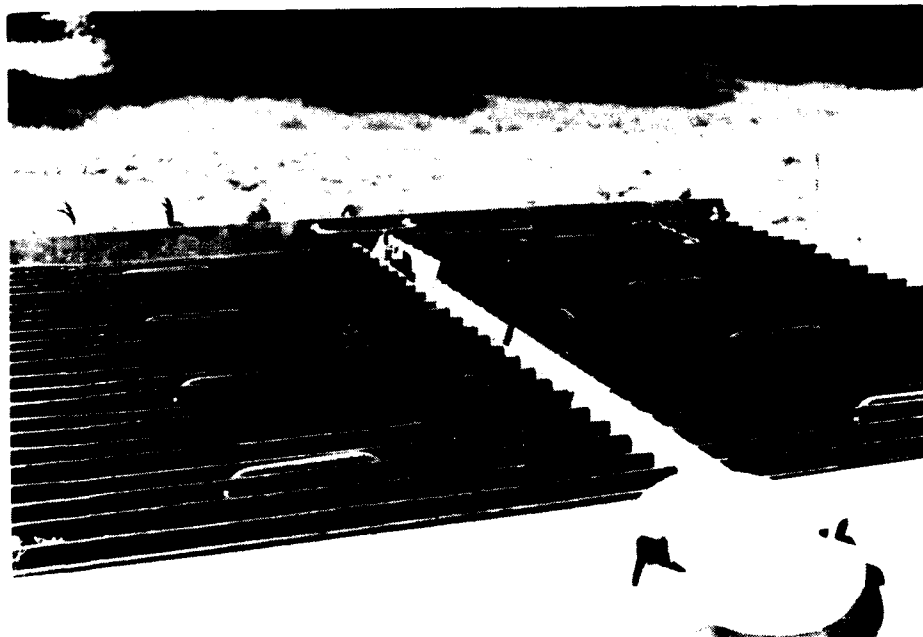
Figure 42. The eight engine grille panels.

1. Reduce the weight of the grilles. Use a lighter material for the grilles other than steel (ie., aluminum).
2. Make the grille sections into one piece that is hinged and can be raised and supported like the hood of a truck.
